Removing or Passing Barriers

12.3 Complete removal of a large weir

RIVER MONNOW

LOCATION – KENTCHURCH, MONMOUTHSHIRE/HEREFORDSHIRE SO41022581
 DATE OF CONSTRUCTION – AUGUST 2011
 LENGTH – 500m (including backwater)
 COST – £100,000 (£60,000 DEMOLITION OF WEIR)

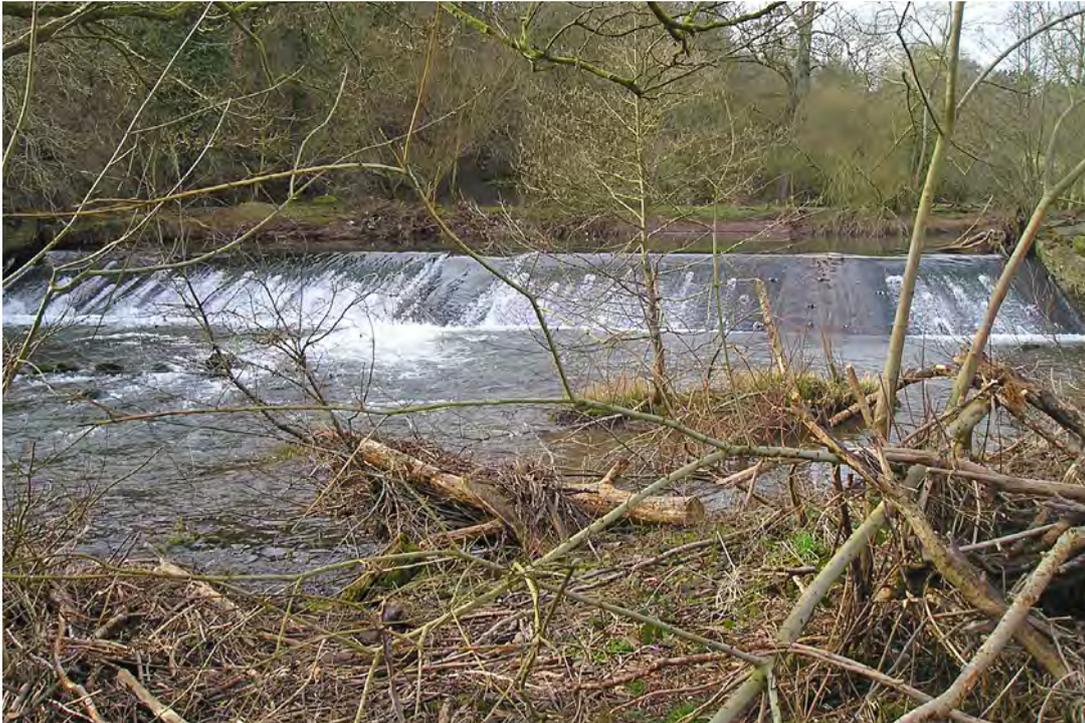
The 2.6m high Kentchurch Weir prior to removal – 2011

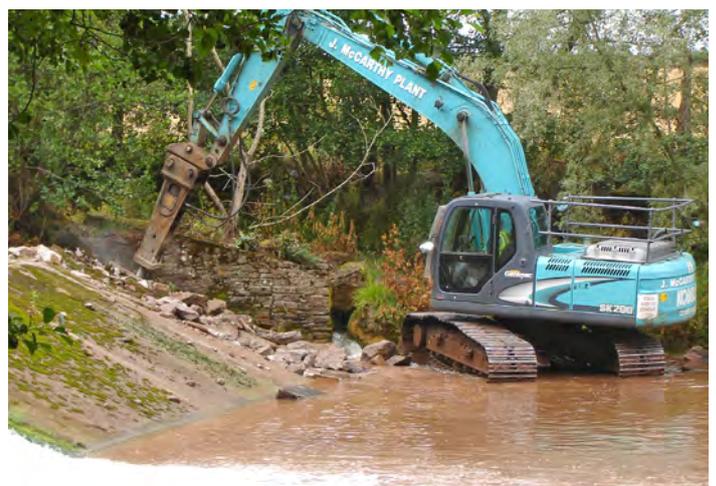
Initial breakout of the weir on the left bank – 2011

To remove the weir a 20 tonne 360° excavator and a 6 tonne swivel skip dumper were used. Demolition started with a 3m width on the left bank which was taken right down to bed level. Once the weir was breached a line of jumbo sand bags was used to channel the flow through this breach. This enabled the contractor to demolish the rest of the weir in the dry as the impoundments had been de-watered.

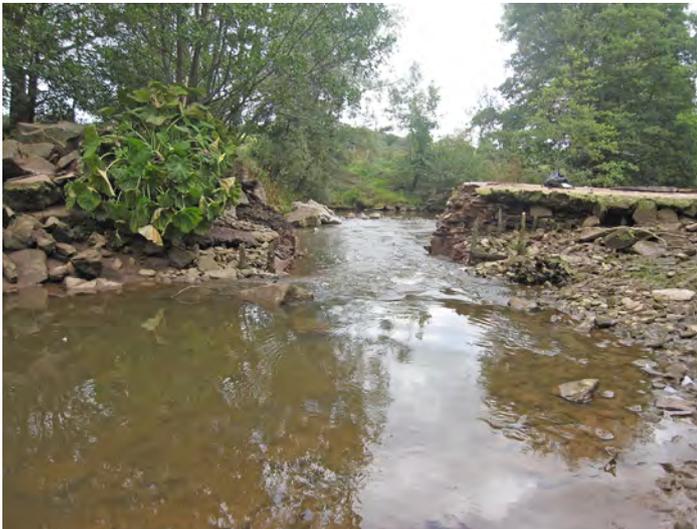
Breach in the weir on the left looking downstream from within the previous impoundment – 2011

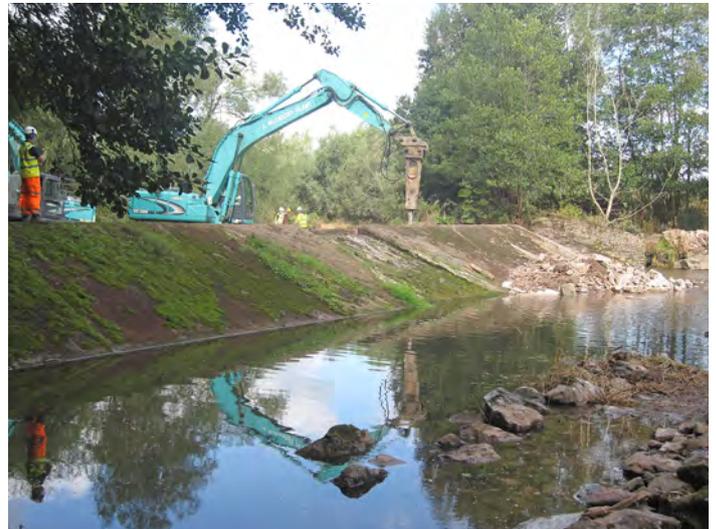
Demolition of the remainder of the weir continued once the upstream impoundment had been de-watered – 2011

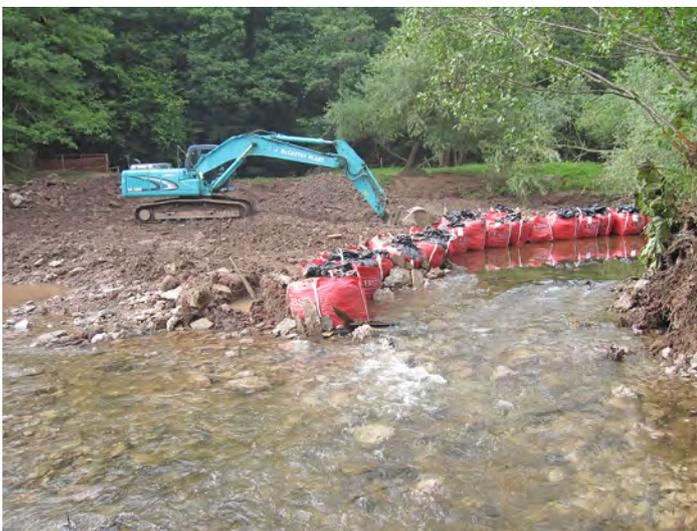
Line of jumbo sandbags channelling the flow through the initial breach allowing the remainder of the weir and material built up behind it to be removed – 2011

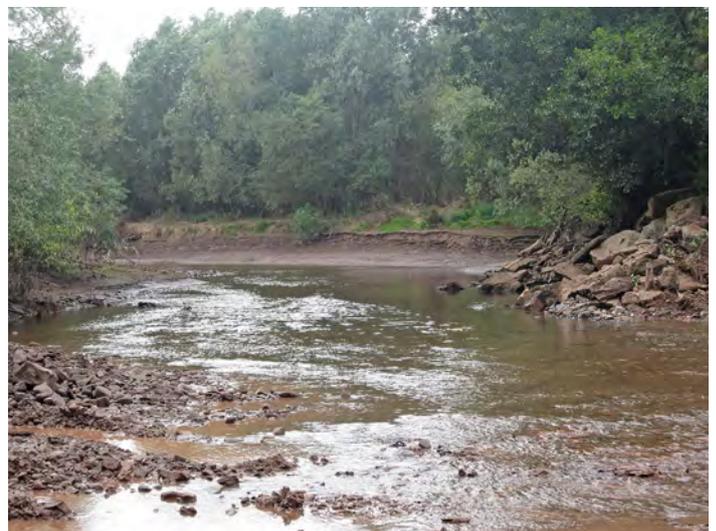
Looking upstream with the weir completely demolished. The drop in water level is evident on the left bank – 2011

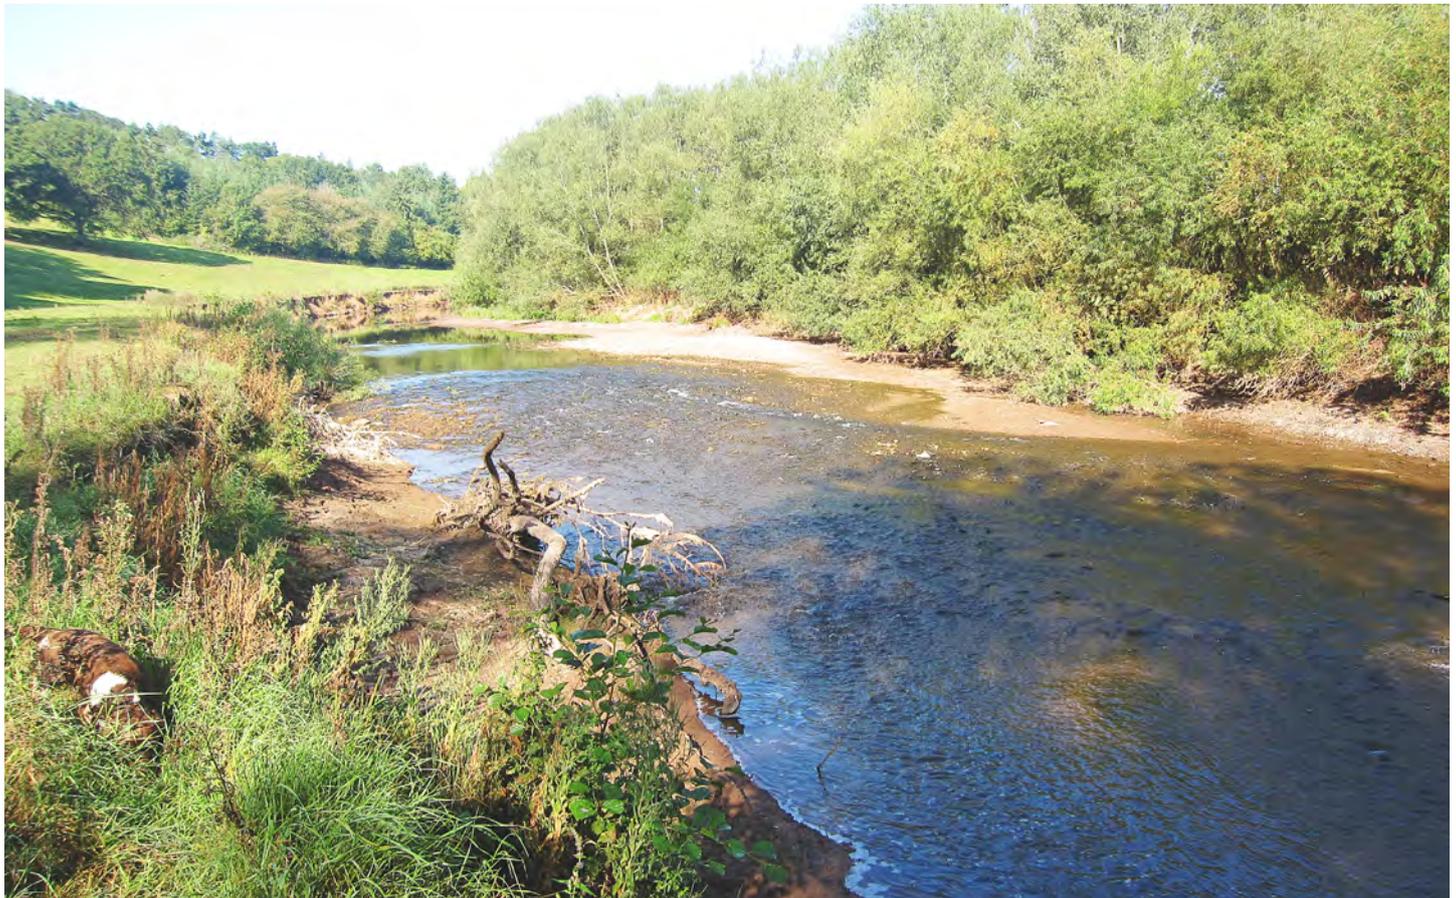
Looking upstream showing the exposed river bed after water levels have been lowered – 2011
