5.6 Fixing whole trees into the river bank for flow diversity

RIVER AVON

LOCATION - AMESBURY, WILTSHIRE. SU15834257

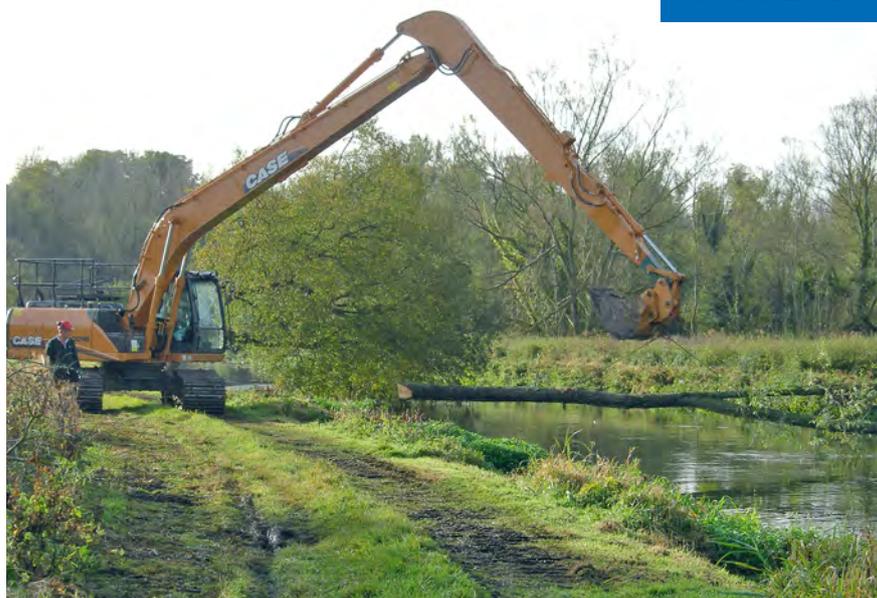
PHOTOGRAPH OF
STAKING METHOD

The sharpened end of tree trunks being pushed 2m horizontally into the bank using a long reach excavator – 2008

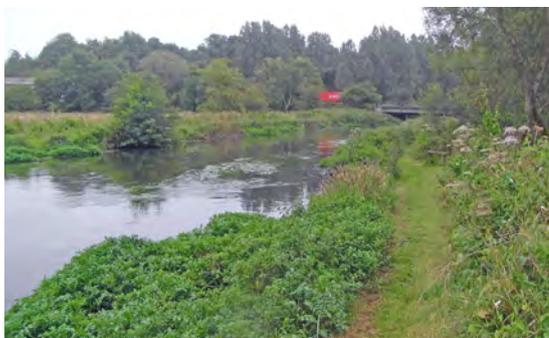
Wide slow flowing channel lacking flow variability – August 2008

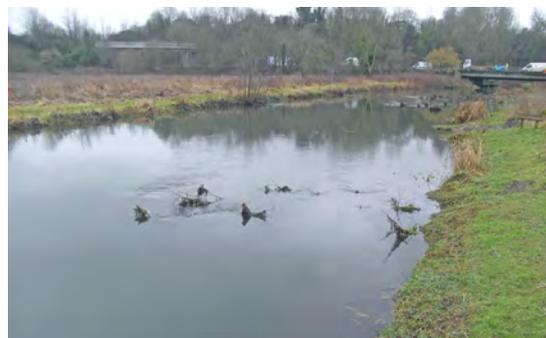
Trees installed on the right bank. Submerged with branches just protruding out of the water – January 2009

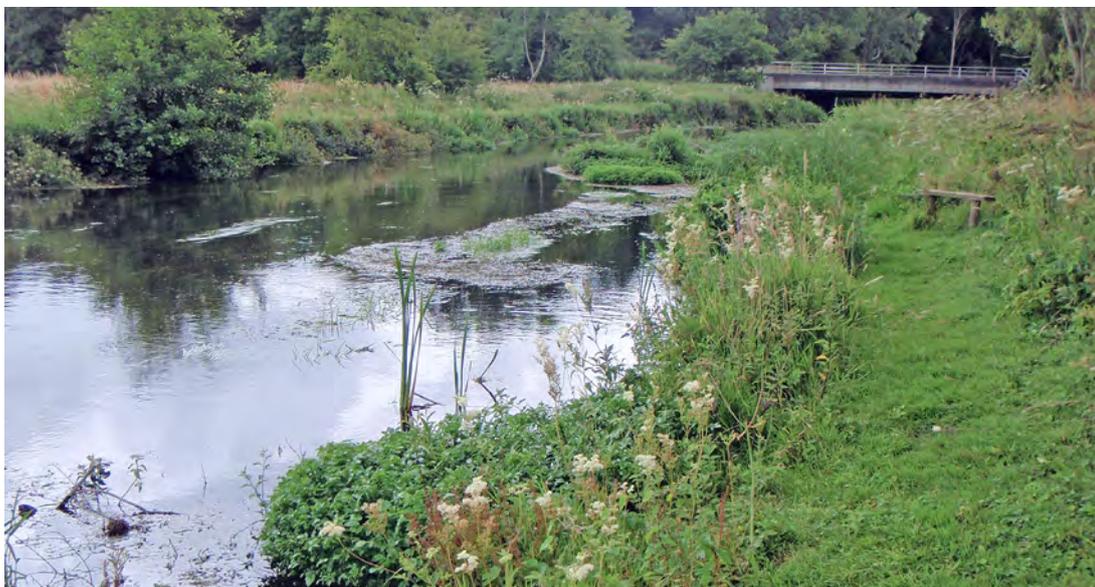
One year later, wood deflectors are collecting rafts of weed and providing shade, cover and habitat. Silt has been deposited between the deflectors.

Marginal plants are now starting to establish in the silt narrowing the channel – July 2009
