# **SITE VISIT INFORMATION**

Photos from the Friday site visits on the Rivers Tame and Sence

## **Croxall Lakes**

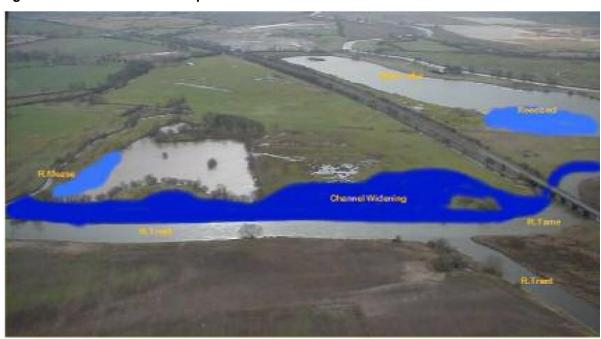
Figure 2 Aerial Photograph annotated with proposed works at Croxall Lakes

Annotated aerial photo showing the scope of the works at Croxall Lakes. © The Environment Agency.

The main aim was to recreate some of the habitats which were once common features along our main rivers prior to their modification in the 19<sup>th</sup> and 20<sup>th</sup> centuries. The river has been heavily engineered in the past and was once much shallower and wider. The project aims at allowing natural river processes to occur by widening the channel (to over 90m in some places) encouraging it to become active in terms of deposition and bed-scouring.
