WHOLE RIVER RESTORATION PLAN FOR THE RIVER KENNET AND RIVER LAMBOURN SSSI

Executive summary

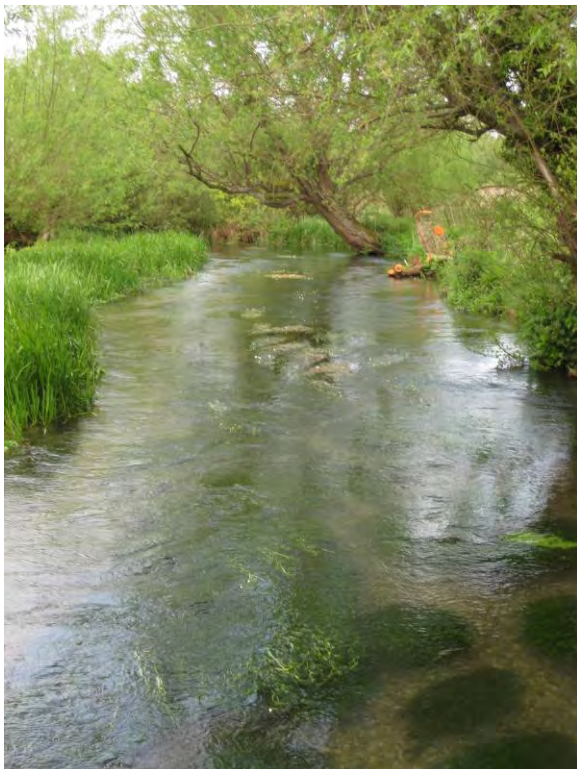
Photo 1 – 'Natural' river Lambourn at Weston

Photo 1-5 below show some of the features that could be considered to indicate good ecological health in the River Kennet and Lambourn (photo 1), the impacts of structures (2 and 4) and the benefits of removal and changes to sluice operation (3 and 5).

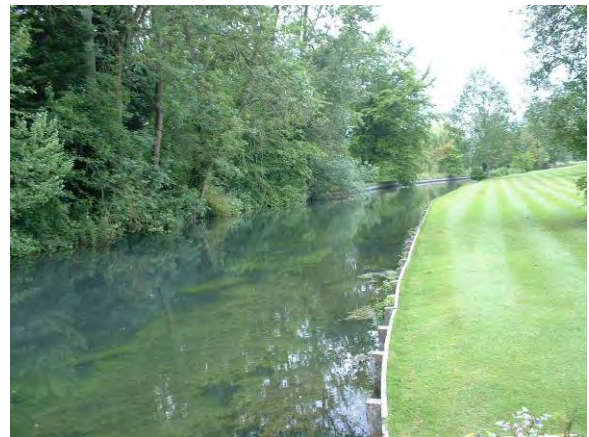
Photo 2- Impounded River Lambourn upstream of Woodspeen mill structure

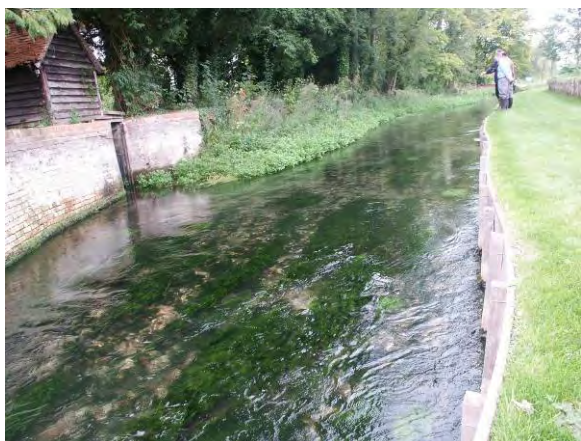
Photo 3 – Woodspeen Mill following structure removal

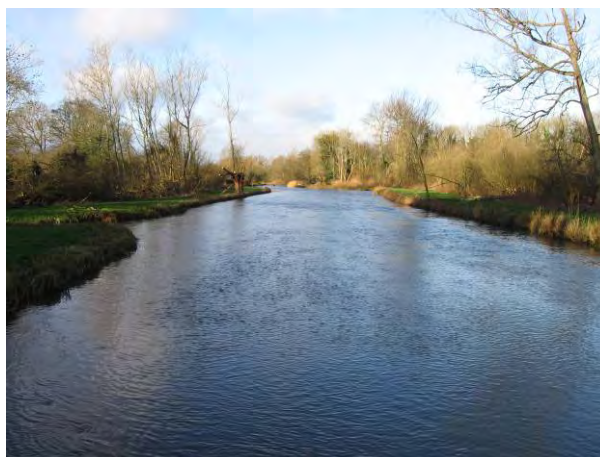
Photo 4 – River Kennet at Avington before restoration and change in sluice management

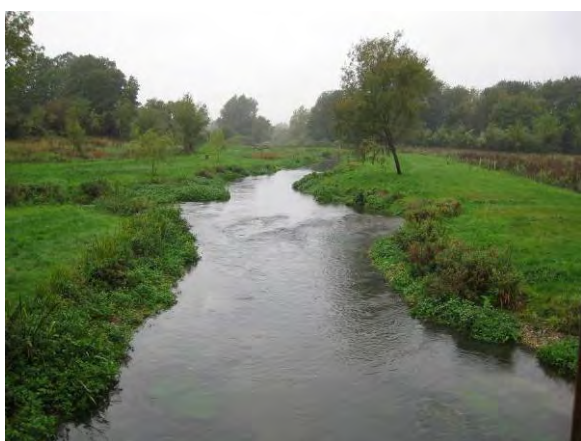
Photo 5 – River Kennet at Avington following restoration and change in sluice operation
