Enhancing Straightened River Channels

3.10 Sinuous low-flow course in an over-wide urban channel

RIVER SOMER

LOCATION - MIDSOMER NORTON, SOMERSET ST66495420

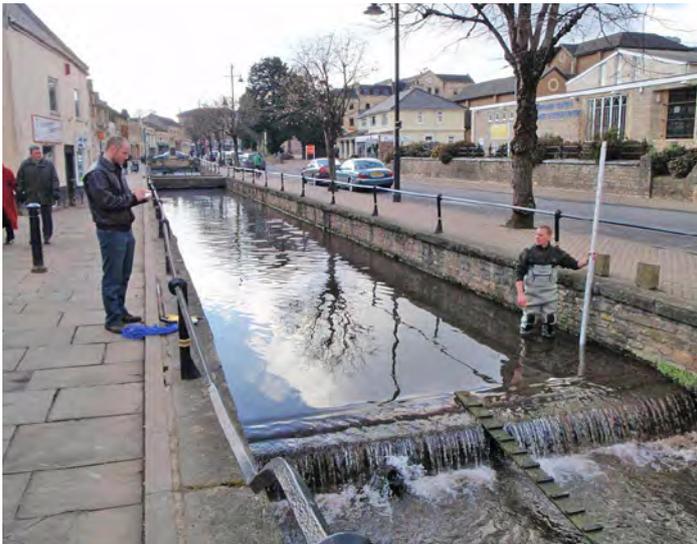
Measuring existing channel dimensions prior to works - 2011

The pre-restoration reach had a mean water depth of 0.5m and a mean channel width of 4.5m.

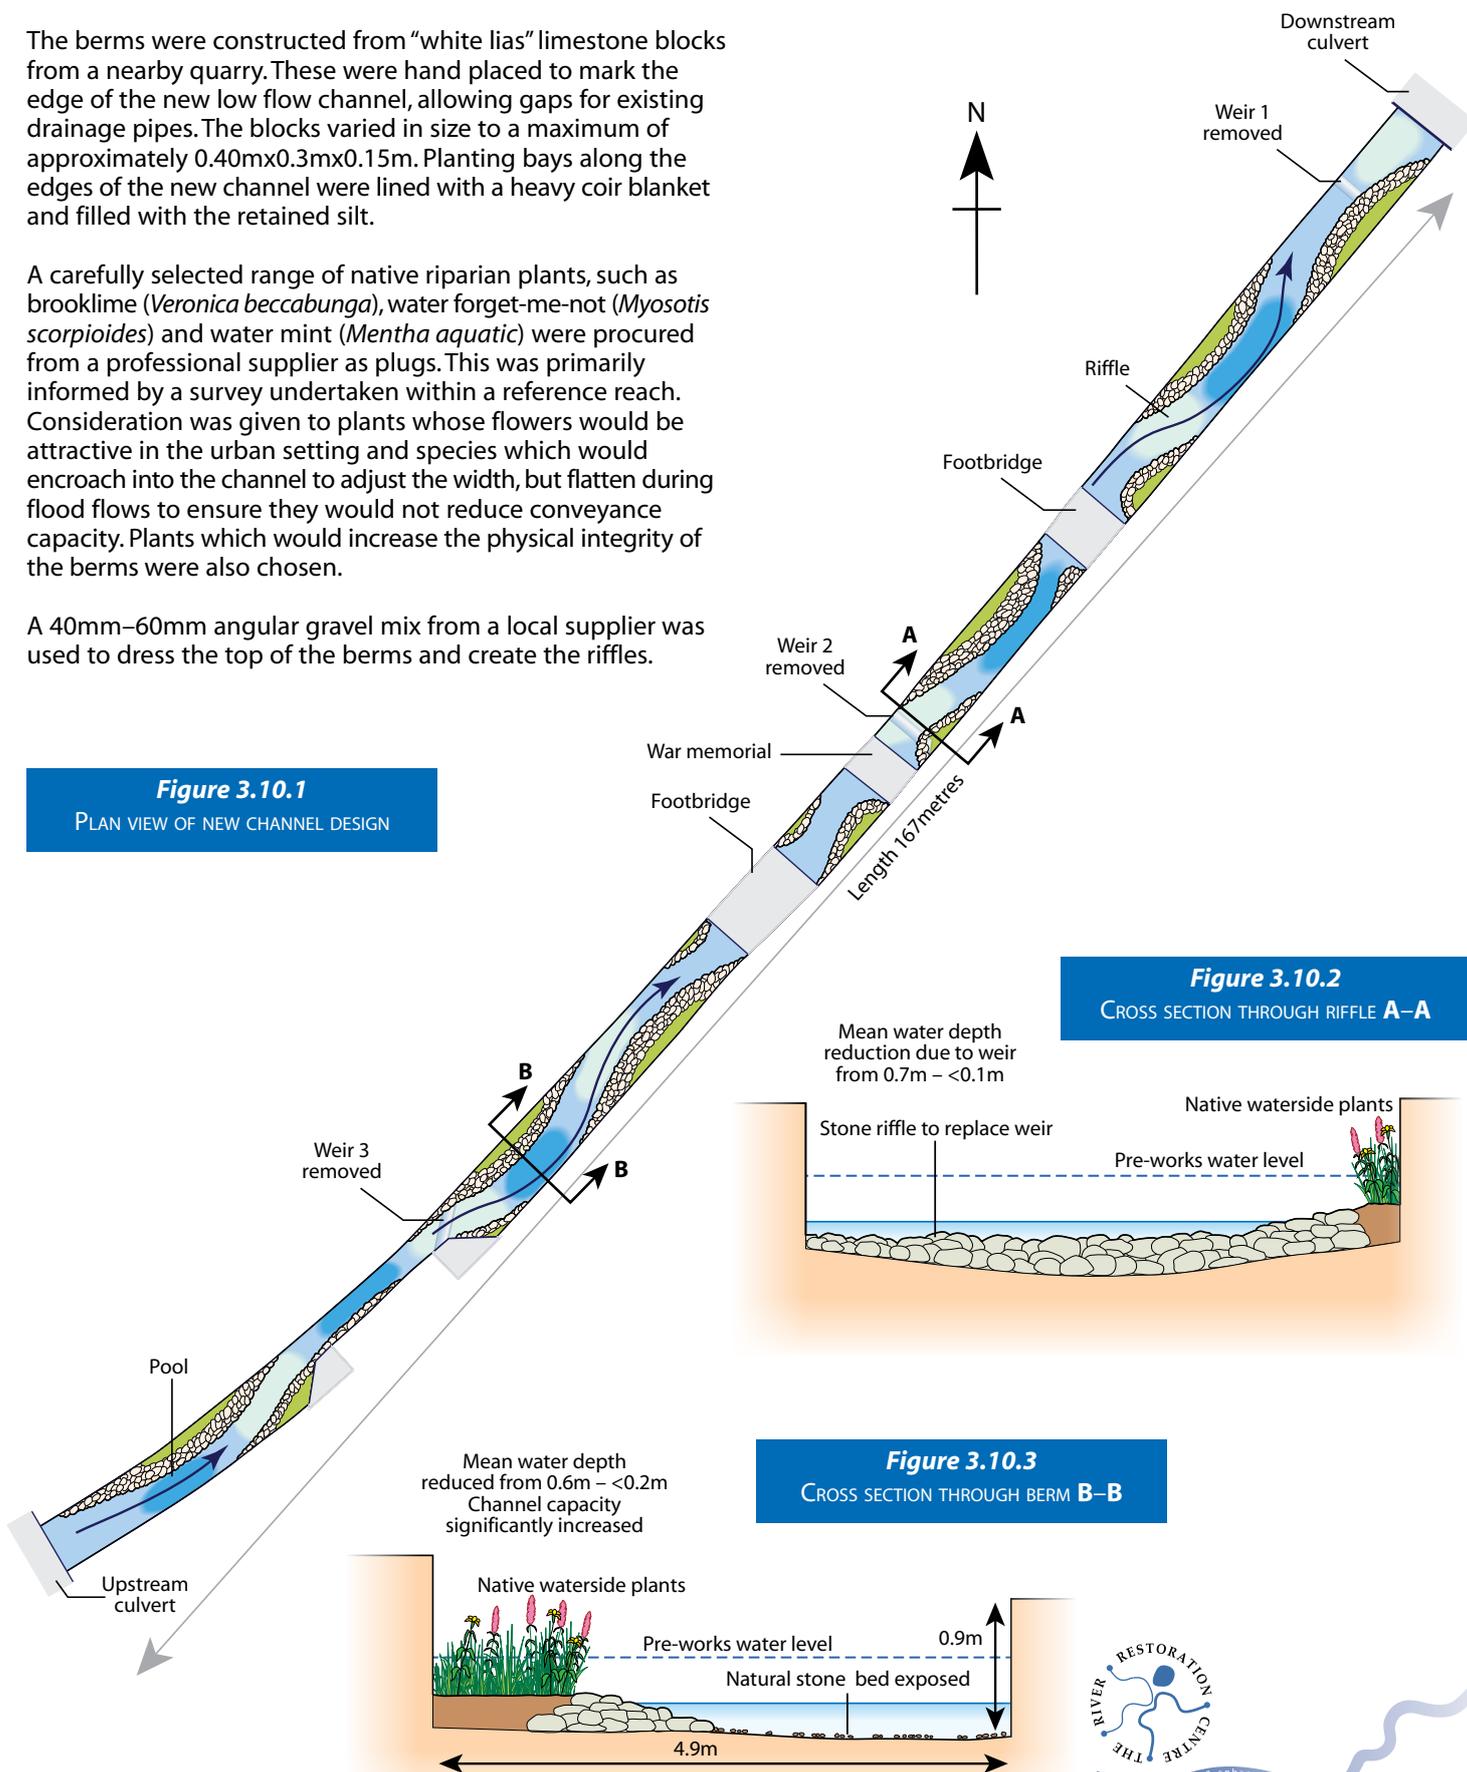
Figure 3.10.1

PLAN VIEW OF NEW CHANNEL DESIGN

The new sinuous channel design was constructed by forming berms to create a low flow channel, with higher flows able to over-top these features. This enabled the required capacity to be provided. The flood relief channel maintained the current level of flood defence to the High Street and allowed flows to be temporarily diverted away from the reach during construction.

The low flow channel width and spacing of the pool riffle sequence was informed by a suitable reference reach from the Somer catchment.

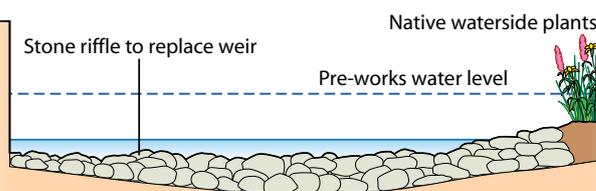
Figure 3.10.2

CROSS SECTION THROUGH RIFFLE A-A

Mean water depth reduction due to weir from 0.7m – <0.1m

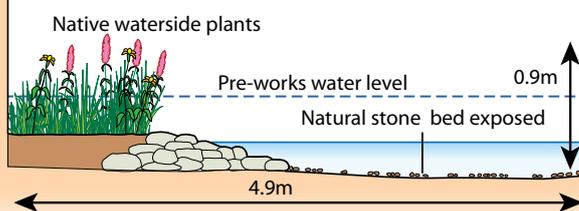
Figure 3.10.3

CROSS SECTION THROUGH BERM B-B

Mean water depth reduced from 0.6m – <0.2m
Channel capacity significantly increased

The berms were constructed from “white lias” limestone blocks from a nearby quarry. These were hand placed to mark the edge of the new low flow channel, allowing gaps for existing drainage pipes. The blocks varied in size to a maximum of approximately 0.40m x 0.3m x 0.15m. Planting bays along the edges of the new channel were lined with a heavy coir blanket and filled with the retained silt.

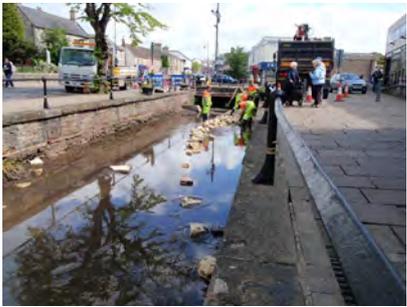
Limestone blocks laid out to delineate berm structure edges – 2011

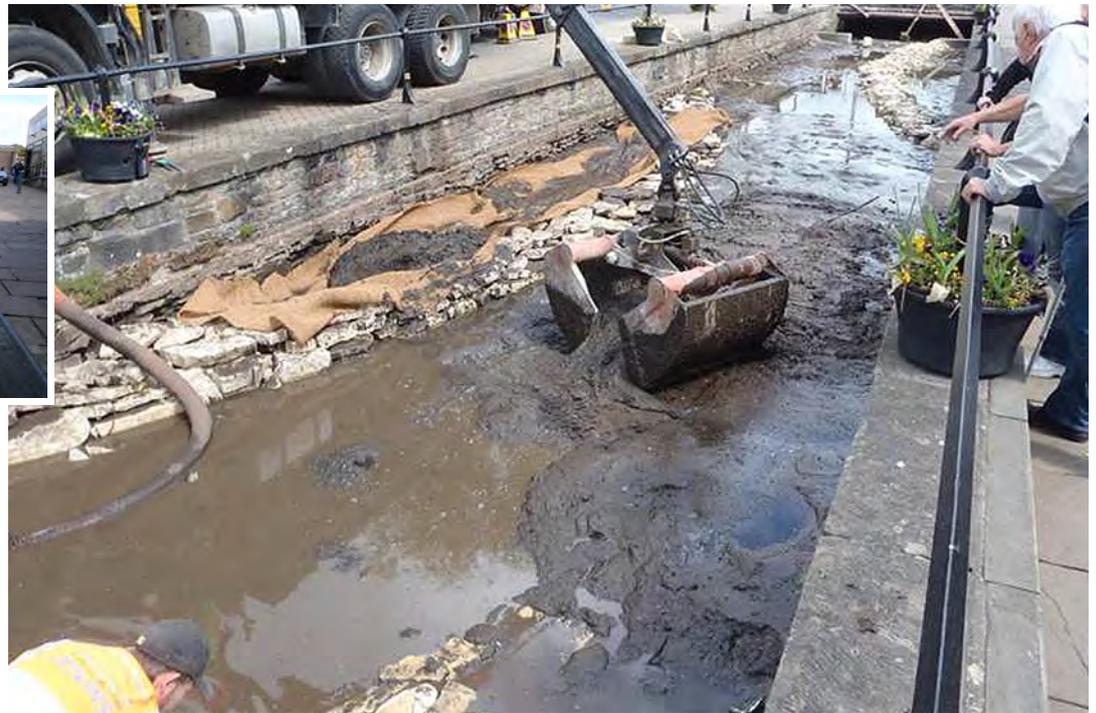
Silt is used to fill the marginal berms ready for planting – 2011

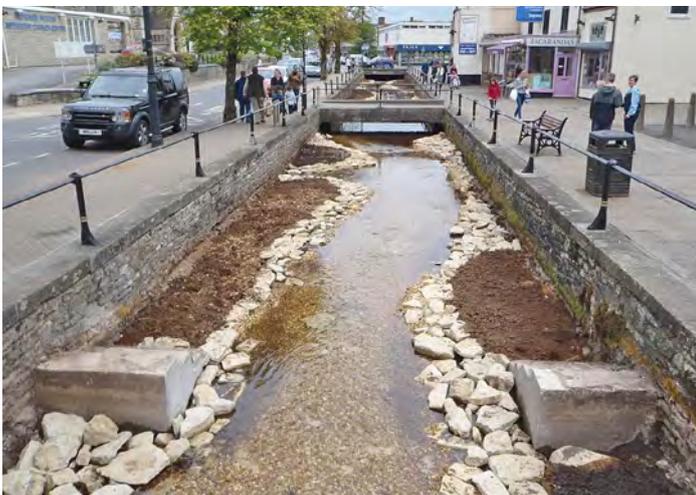
Two sides of the weir have been retained and incorporated into the berms – 2011

Accumulations of silt were removed from the channel and retained on site for use as backfill in the new design. Three weirs were removed, retaining only the two sides of each structure which were incorporated into the channel berms. This was at the request of the council who wanted to be able to install temporary boards across the channel to retain water depth, should severe drought conditions occur.

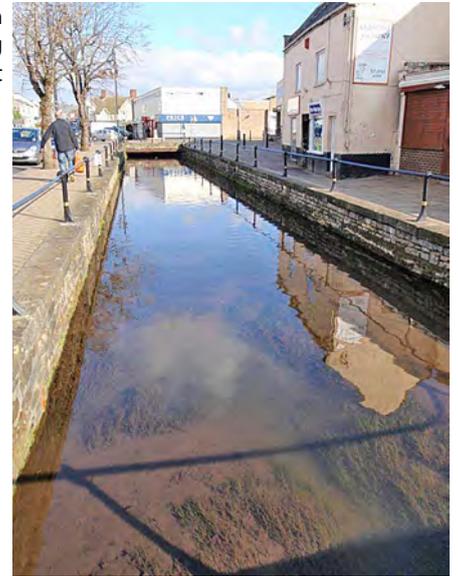
Section of the reach before, showing significant sediment accumulation – 2011

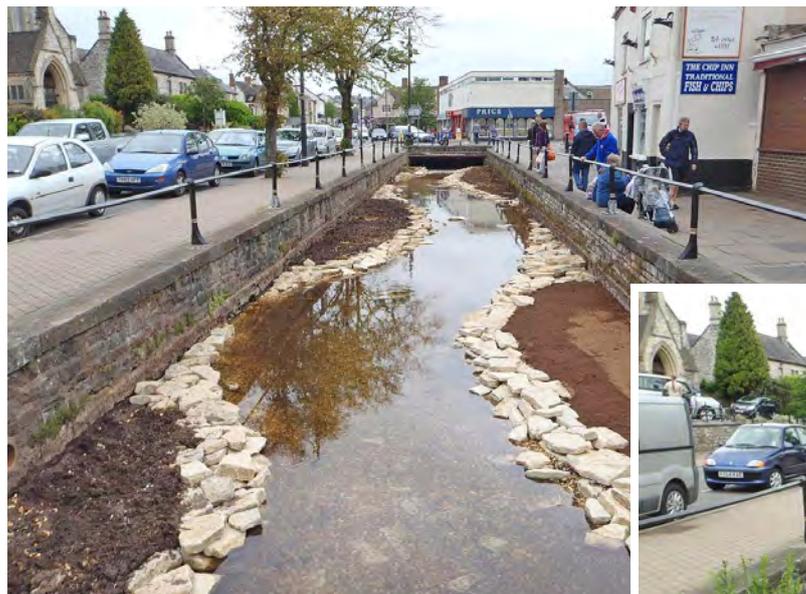
During construction, just before the planting phase is due to commence – 2011

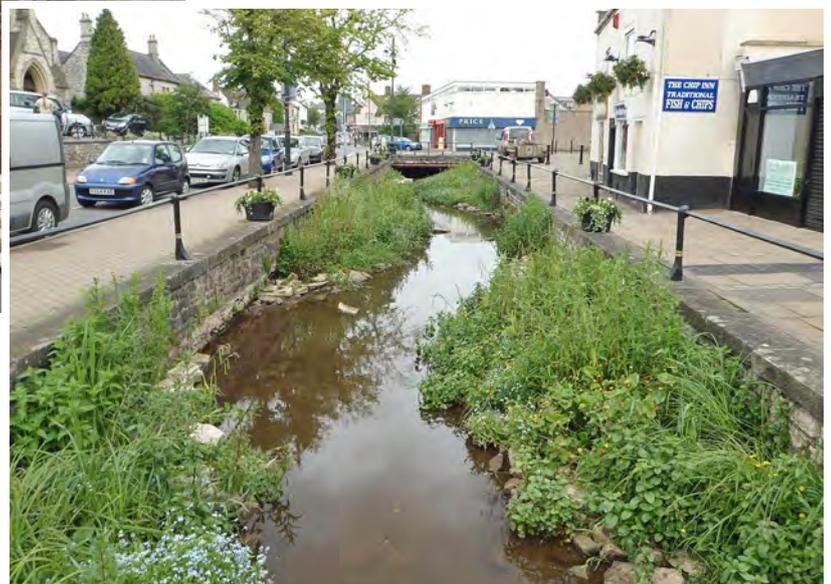
One year after restoration showing development of diverse bankside vegetation – 2012

This assessment indicated that the berms were intact and in good condition despite several high flow events. Plant communities had matured well, providing a diverse marginal habitat.
