# Revetting and Supporting River Banks

## 4.1 Willow spiling

### RIVER SKERNE

LOCATION – DARLINGTON, CO DURHAM, NZ301160

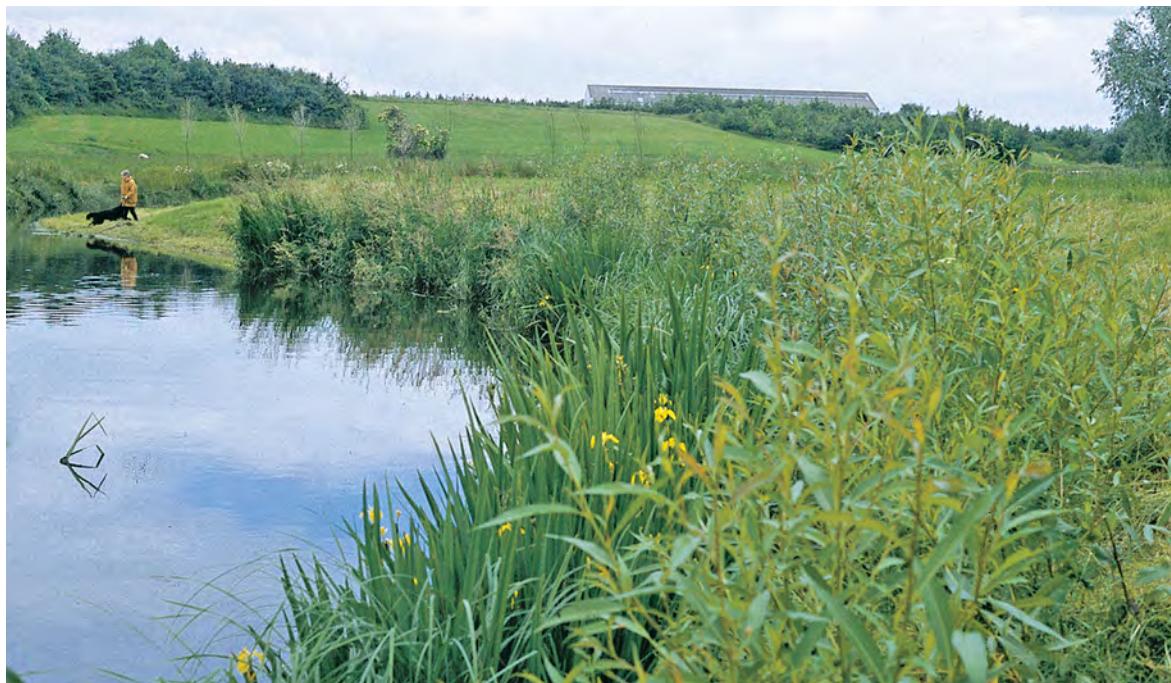
Willow spiling 2 years after construction

The river banks at both entry and exit sites are stable and silts are accumulating around a dense line of willow shoots up to 2.5m tall. The planted ledges are equally densely covered with marginal aquatic species that are similarly accumulating silts. Exceptionally, growth over one short length has been limited to the willow posts introduced behind the spiling. This is because the spiling poles, installed in the autumn, had been stored for too long in dry conditions.

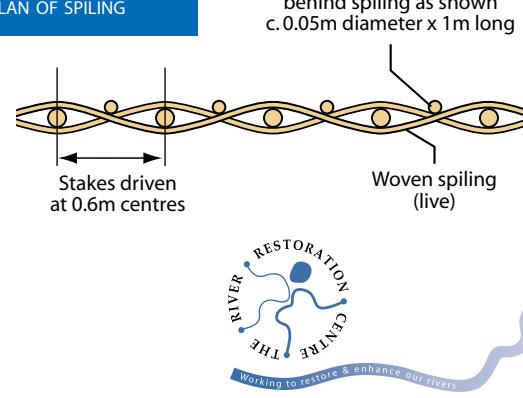
**Figure 4.1.3**

This revetment technique utilises willow poles woven around vertically driven stakes and is particularly suited to steep river banks that need both support and erosion protection.

PLAN OF SPILING
