5.7 Felling and placing trees for habitat and flow diversity

RIVER BURE

LOCATION - BLICKLING ESTATE, NORFOLK. TG161301

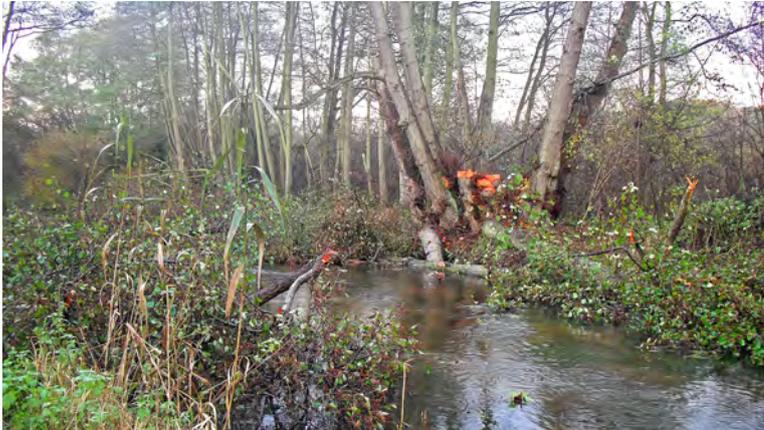
1 Select trees which are already leaning over the water and are likely to eventually fall in the river.

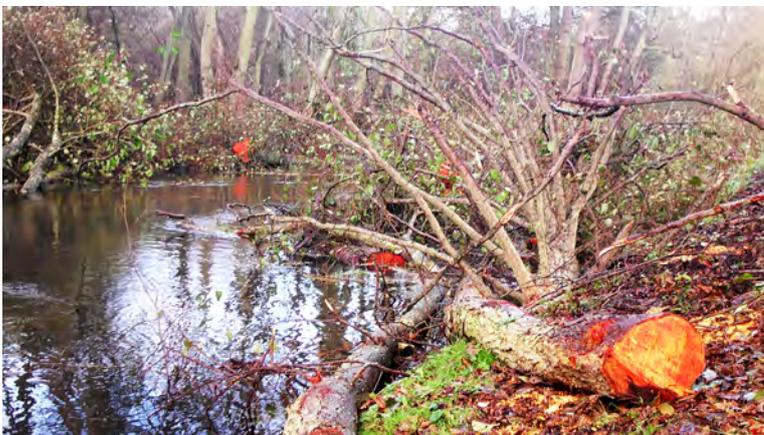
2 Fell them so that they remain attached to the stump (often referred to as 'laying' or 'hinging') or so that part of the trunk stays on the bank. Allow branches to penetrate the river bed to increase the stability of the tree and to prevent the tree from rolling or being mobilised by the flow.

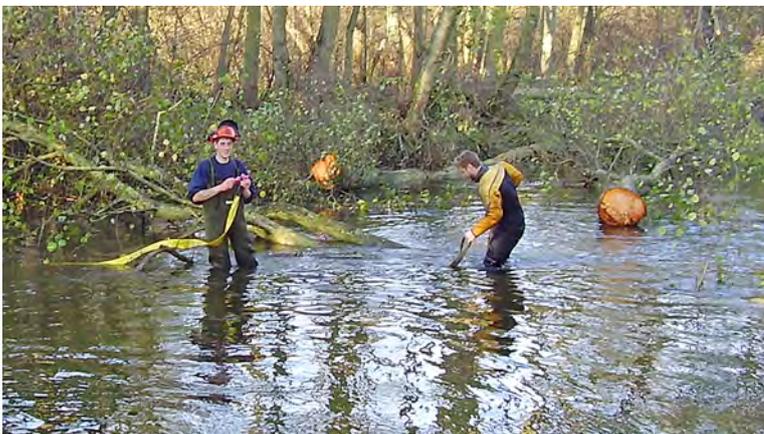
3 Modify the position if necessary to maintain an open channel if the felled tree blocks the flow. If absolutely necessary, prevent movement with a 1.5m stake.

Once the wood is waterlogged it will become less prone to movement at low to medium flow events. However, significant flood events may still cause major re-working and movement. Similar schemes elsewhere have used tethering to prevent downstream movement of placed woody material.

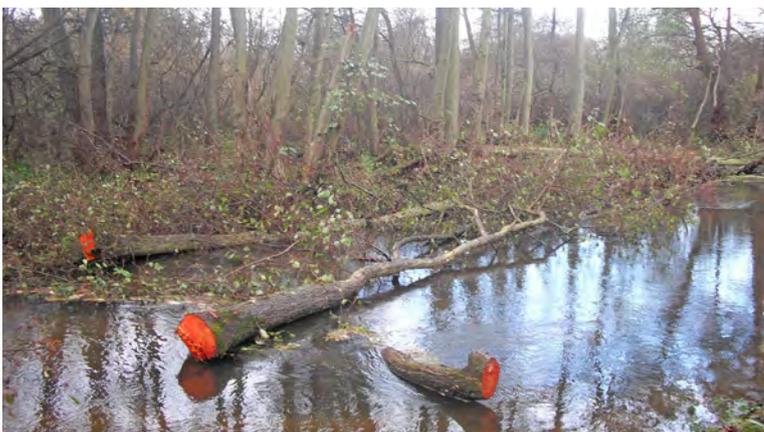
4 Fell more than one tree on top of each other to provide a greater mass to the structure and give a dense web of branches.

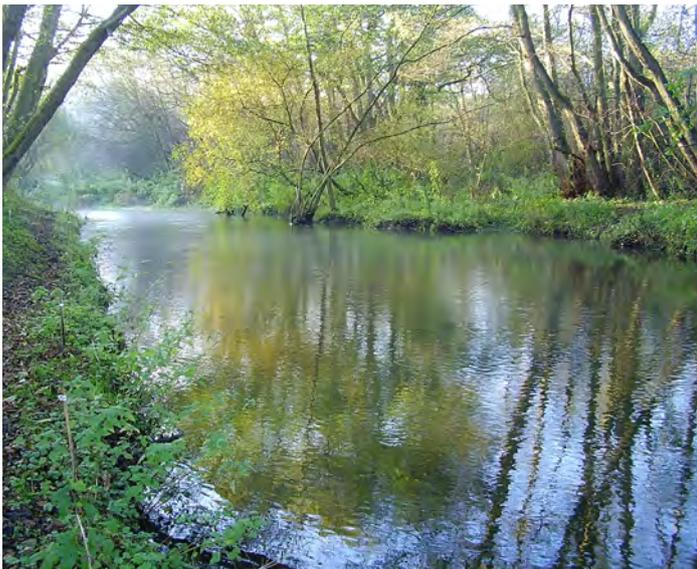
Before – Over widened silt laden channel

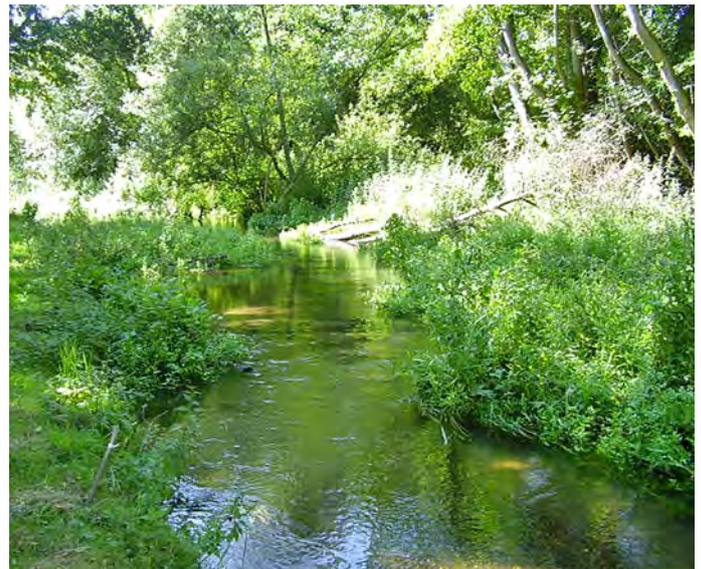
After – With narrowed channel and vegetated berms where silt has built up downstream of the felled trees – 2012

There is scouring of fine sediment and exposure of gravel in areas where the structures have concentrated flow. The movement of sediment and the colonisation by marginal plant species around the wood structures can be seen. These observations appear to support effective narrowing of the over-widened channel and an increase in physical habitat complexity.
