11.2 Clay Lined River

RIVER NITH

LOCATION - WEST OF NEW CUMNOCK, Ayrshire NS5412

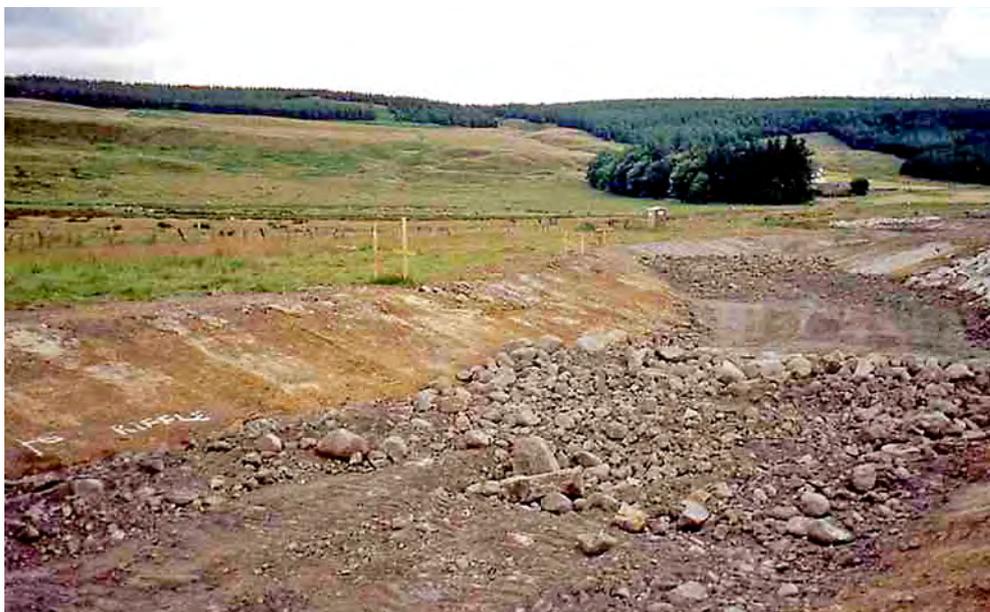
Shaping the new channel within the clay lining

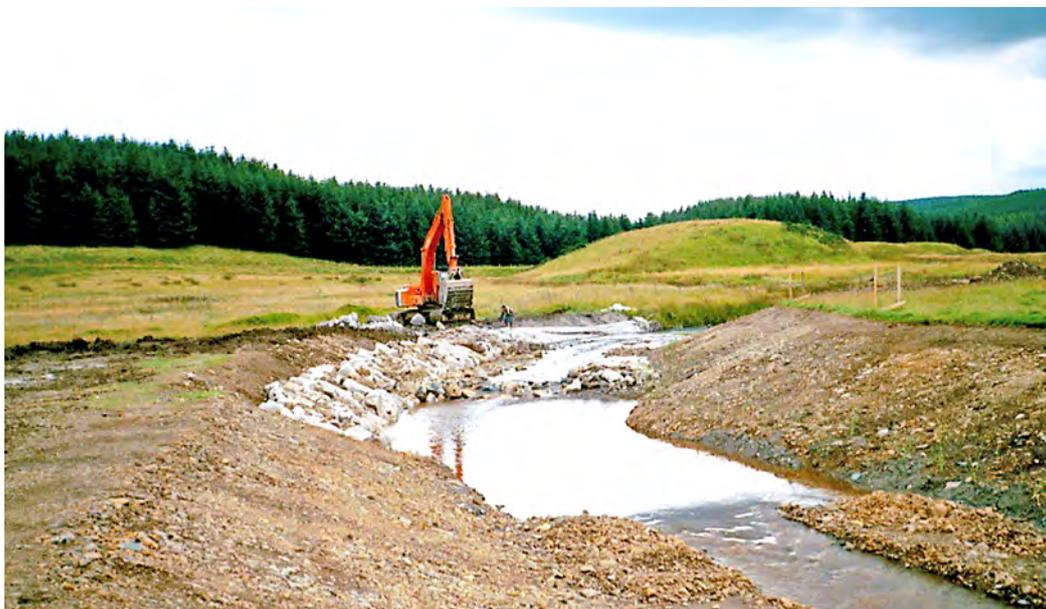
The 'constructed' run-pool-riffle sequence

Run-pool-riffle sequences were constructed by over-excavating the ground where the pools would be located. When forming the bed, cobbles and boulders were pushed into the graded gravel upstream of the pool, forming a raised bed and a central faster 'run' of water entering the pool.

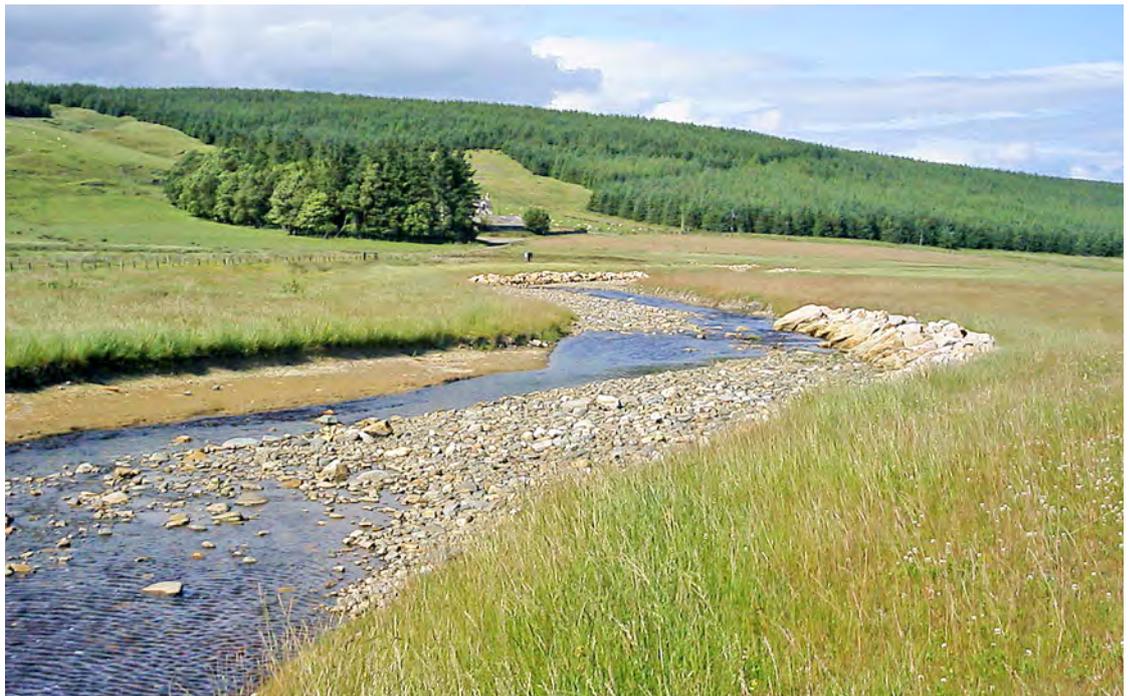
One year on and natural redistribution of in-channel sediments is helping to 'soften' the engineered channel

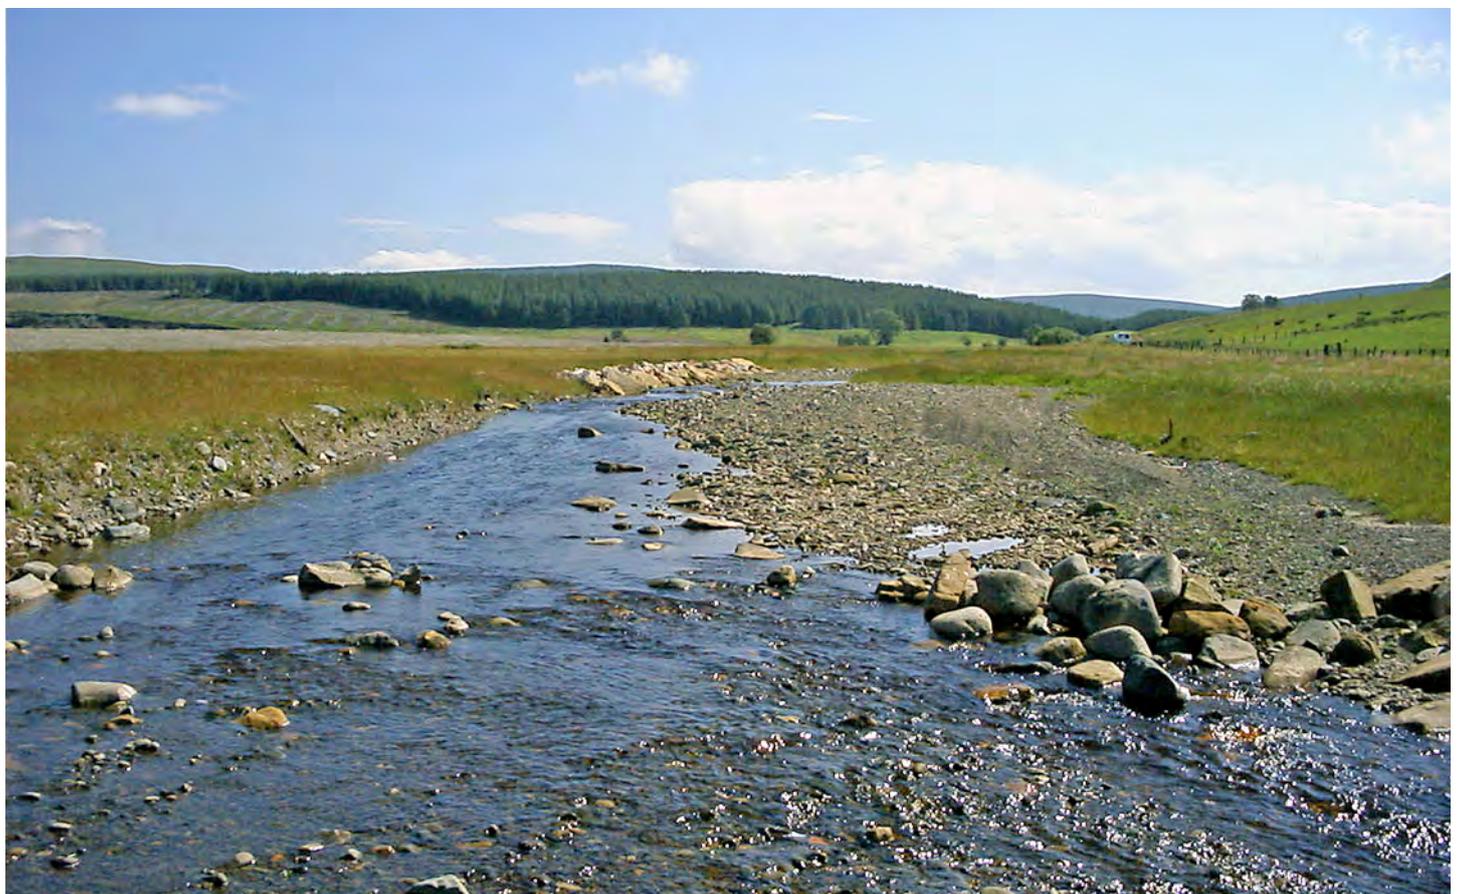
The overwide channel and plentiful bedload gives the river scope to shape its bed

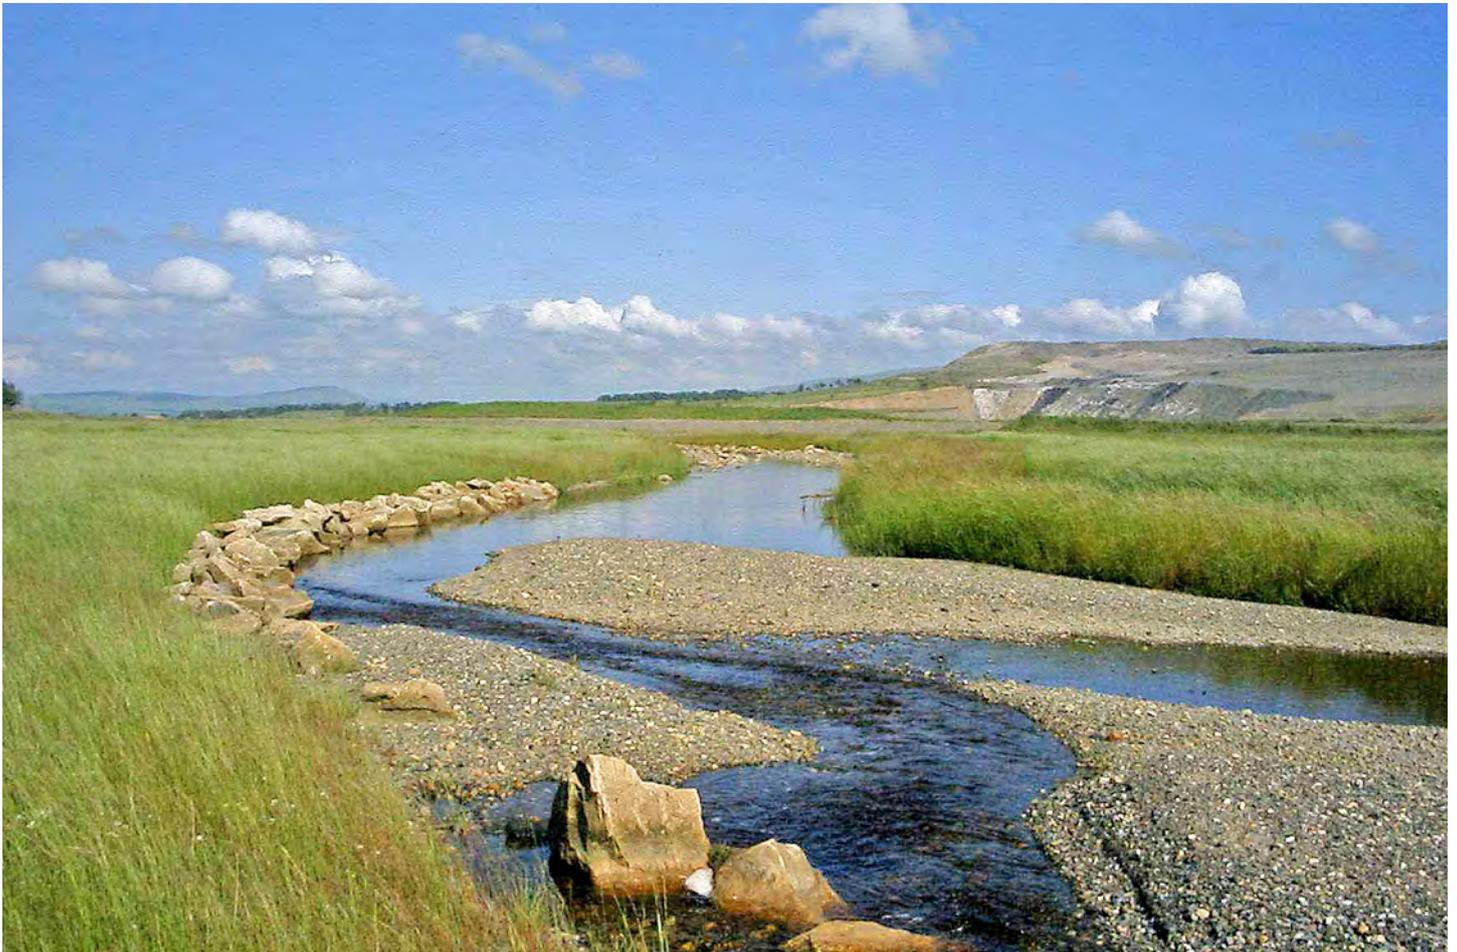
The rip-rap is still very evident but the in-river form is developing well

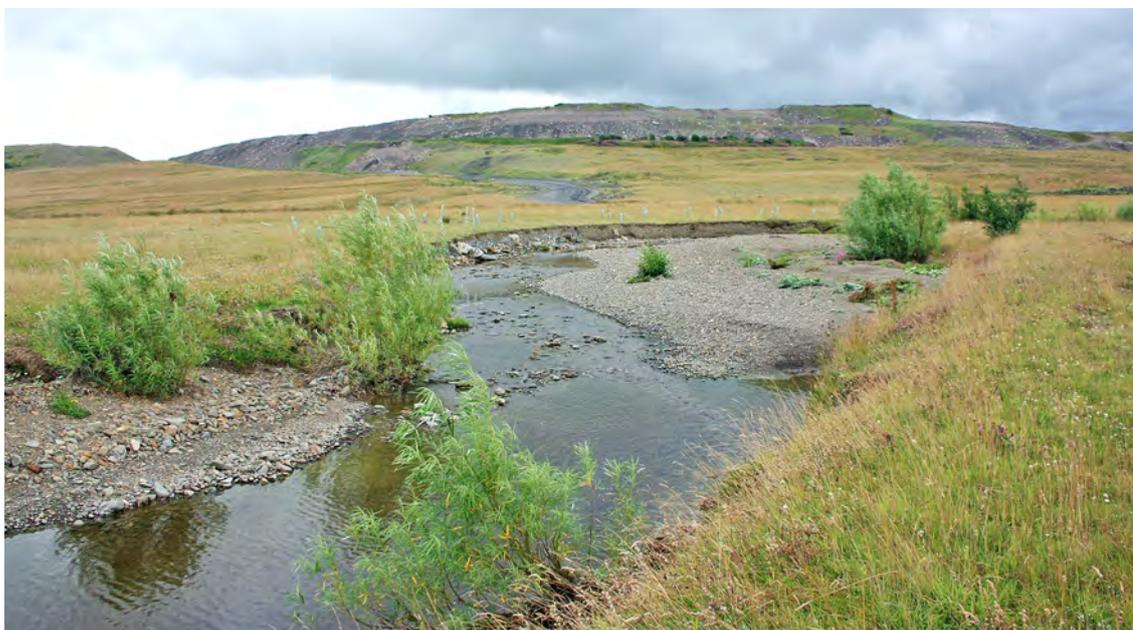
The channel realigned in 2004 after 7 years. Marginal vegetation has established and natural morphological processes are taking place – August 2011

In 2004 the channel was moved again, roughly along the course of the original, because of a commercial decision to extend coal mining activities. This allowed the channel design to incorporate lessons from the former project's successes and limitations.
