Removing or Passing Barriers

12.1 Restoring an on-line lake to a chalk stream

BABINGLEY RIVER

LOCATION - HILLINGTON, NORFOLK TF72532629

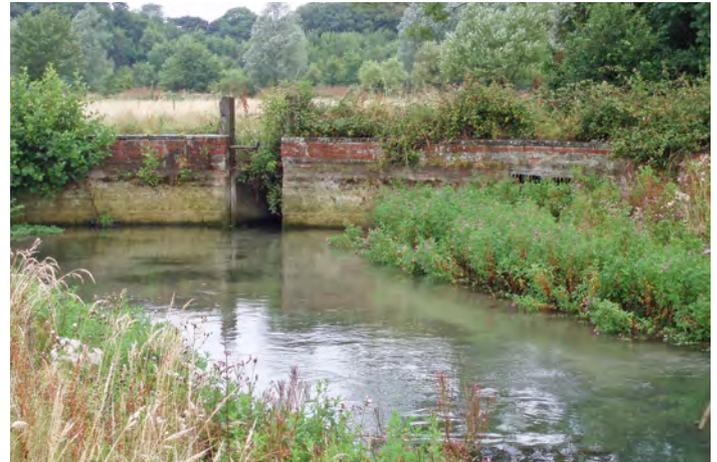
Downstream extent of the reach. The sluice boards have been completely removed – August 2007

- 1. Controlled removal of downstream sluice boards**
Six sluice boards, 1.15m high in total, were located at the downstream extent of the reach where the river flows through a 0.6m wide culvert. These maintained the water level in the impounded lake. The boards were removed using a staged approach enabling the lake level to be lowered in a controlled manner and allowing the amount of sediment released downstream to be regulated.

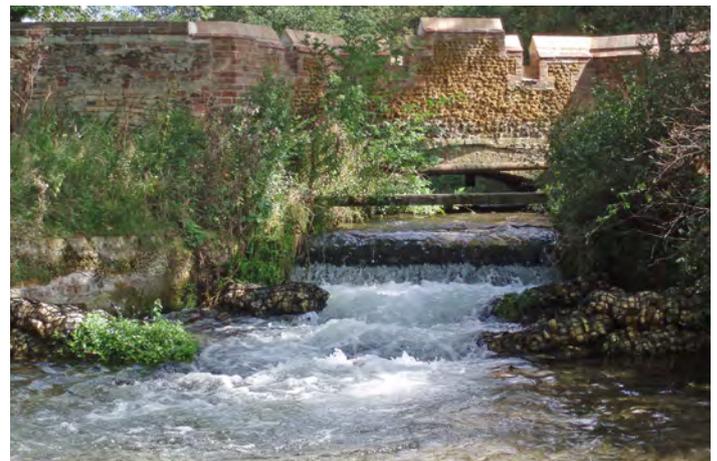
Pool and traverse fish easement after completion. Vegetation has already begun to establish on the rock rolls – August 2007

The easement was constructed using twenty rock rolls to create jumps approximately 0.3m high, the height that brown trout are able to traverse. Two lines of rock rolls were laid across the downstream face of the weir creating three steps for migrating fish to negotiate the barrier. A gap of approximately one metre was built into each line of rock rolls to concentrate the flow. These gaps were offset to reduce flow velocities through the easement and to create fish resting areas.

Some adaptive management of the pool and traverse fish pass has been required. The approach relied on the weight of the bags to keep them in situ. However, some movement did occur due to scouring of the soft bed and the rock rolls would have been better pinned in place. The rock rolls were repositioned manually and stabilised by ensuring that they were located on a hard bed.

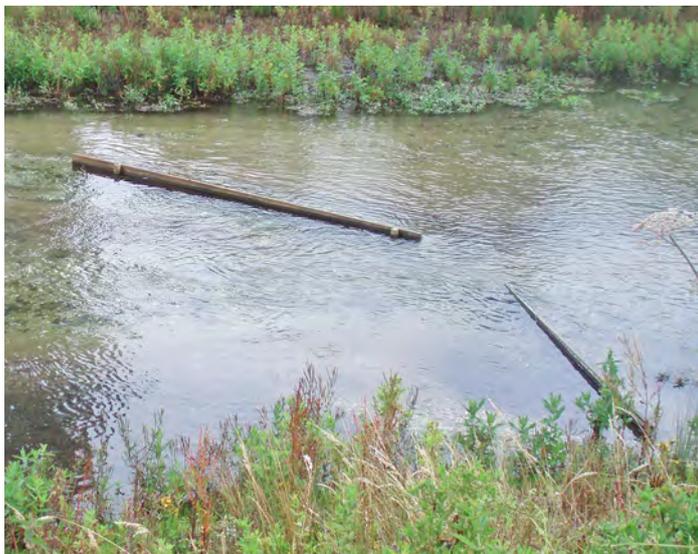
© Environment Agency The newly installed deflectors face upstream and concentrate flow. The old silt bed has formed new banks and has since been colonised by vegetation – February 2007

The deflectors were generally installed in pairs, some opposite each other and some offset. The locations were determined by working with the river. Hillington Fly Fishing Club was responsible for this work so the addition of the deflectors did not contribute to the Environment Agency project cost.

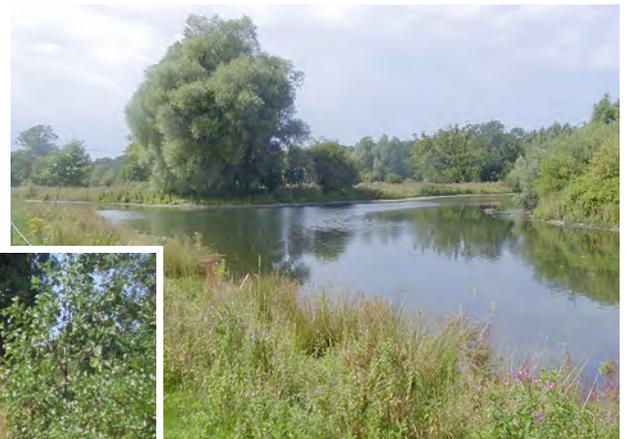
Prior to restoration works. The on-line lake was over deep due to the presence of sluice boards impounding water – August 2006

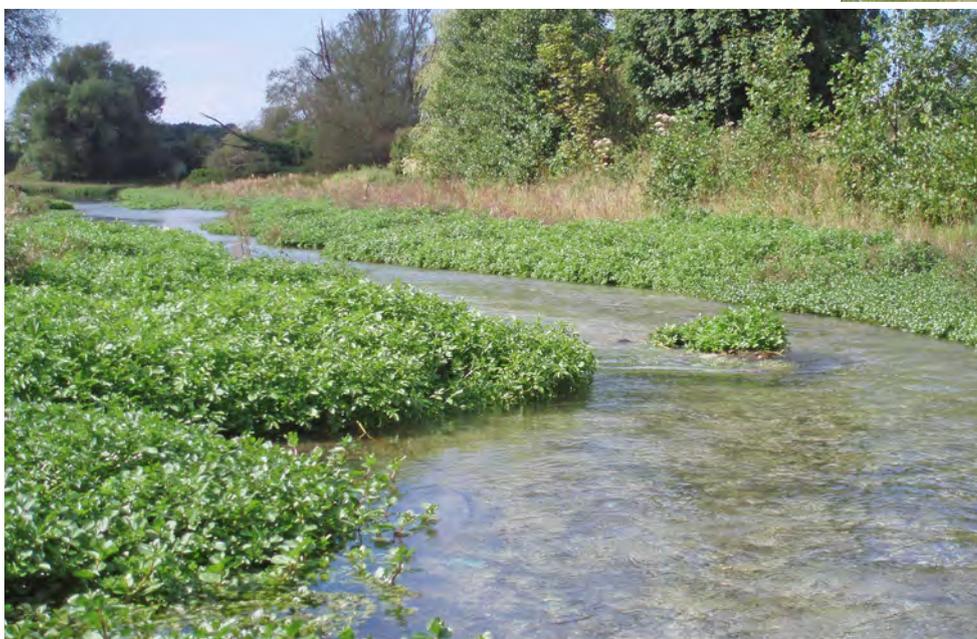
Post restoration works. The channel is narrower and shallower with diverse marginal vegetation and good spawning habitat – September 2007

The upstream section of the restored river was quick to expose hard bed, and braided channels have formed here. The combination of newly exposed gravels and improved flows has increased the amount of available spawning habitat.
