Remeandering and ecological restoration of a lowland stream in Belgium

RESTORE- Understanding River Restoration, De Bilt 25-26 juni-2013

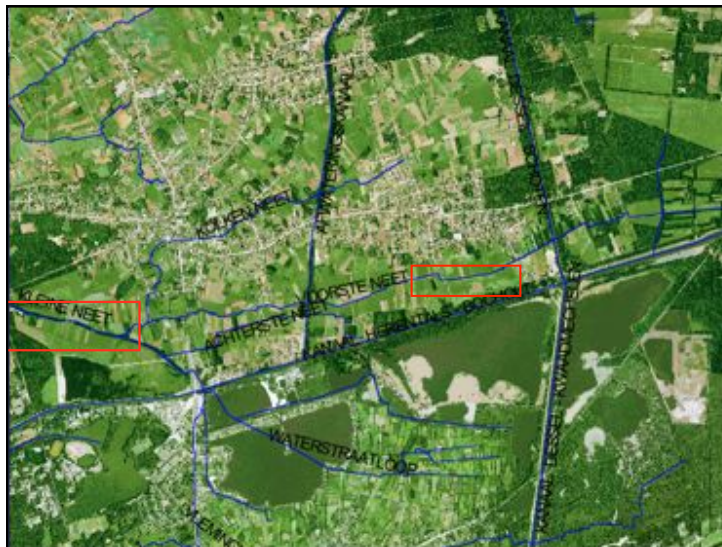
**Original reach
Witte Nete**

Original reach		average	
Average width at waterlevel (m)	6.84	Average discharge (m ³ /h)	1.826
Average width top levee (m)	9.29	Maximum discharge (m ³ /h)	12.480
Average Water depth (m)	0.52	Slope	0.44
Average depth levee (m)	1.25	Sinuosity	1
Water velocity (m/s)	0.2 - 2

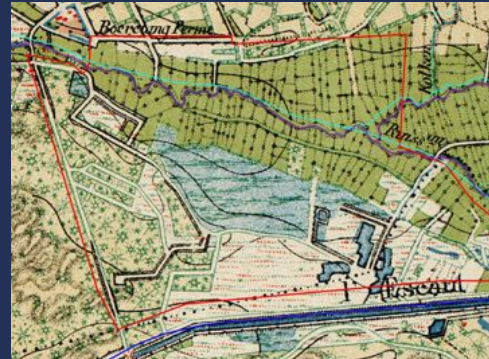
Sinuosity based on historical maps
